Manhole Inspection Summary

Manhole # **S33A__018MH**

Insp Date: **4/22/08 2:29 PM**

Location Address: **509 PARK AVE**

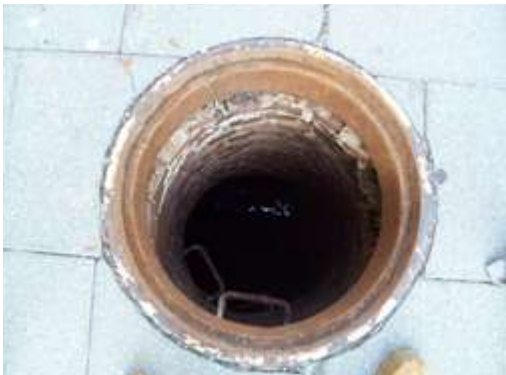
Top View

Offset: **2** (in.)

FRAME OFFSET

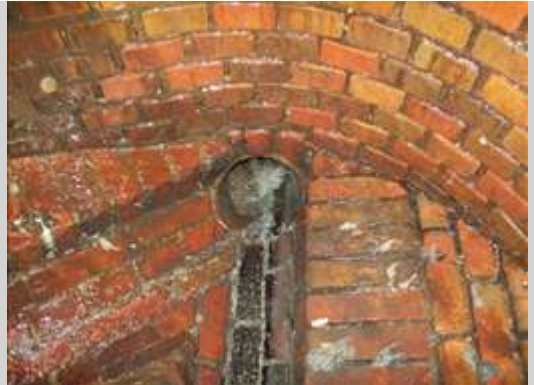
12 O'Clock Outflow

8 in. Circular Gravity Sewer
Pipe Out @ 12 O'Clock

Infiltration: **None** Pipe Seal Cond: **Sound**

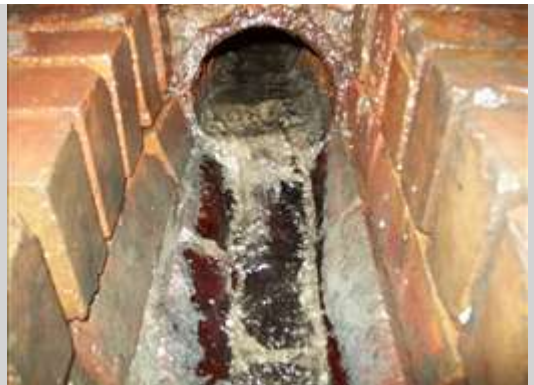
6 O'Clock Inflow

6 in. Circular Gravity Sewer
Pipe In @ 6 O'Clock

Infiltration: **None** Pipe Seal Cond: **Sound**

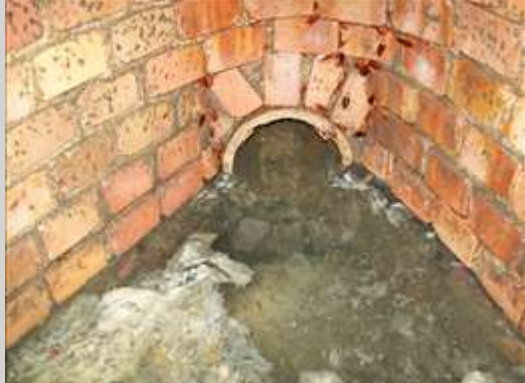
8 O'Clock Inflow

8 in. Circular Gravity Sewer

Pipe In @ 9 O'Clock

Infiltration: **None** Pipe Seal Cond: **Sound**

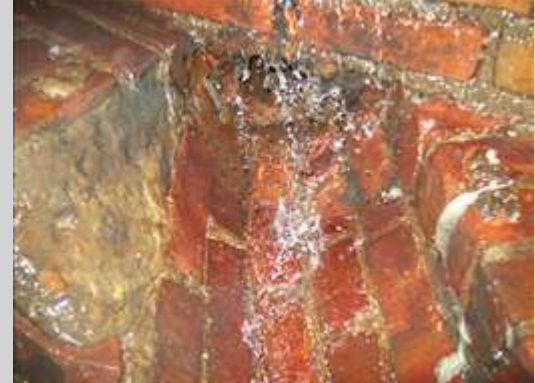
Drop In @ 9 O'Clock

Drop: **Inside** **Direct**

Drop Condition: **Partly Clogged**
